Revitalizing our Church Building for *more* years of Christian service!

**POSSIBLE CAPITAL CAMPAIGN ELEMENTS
FOR YOUR CONSIDERATION ~**

Comments from the Capital
Campaign Feasibility Study
Committee

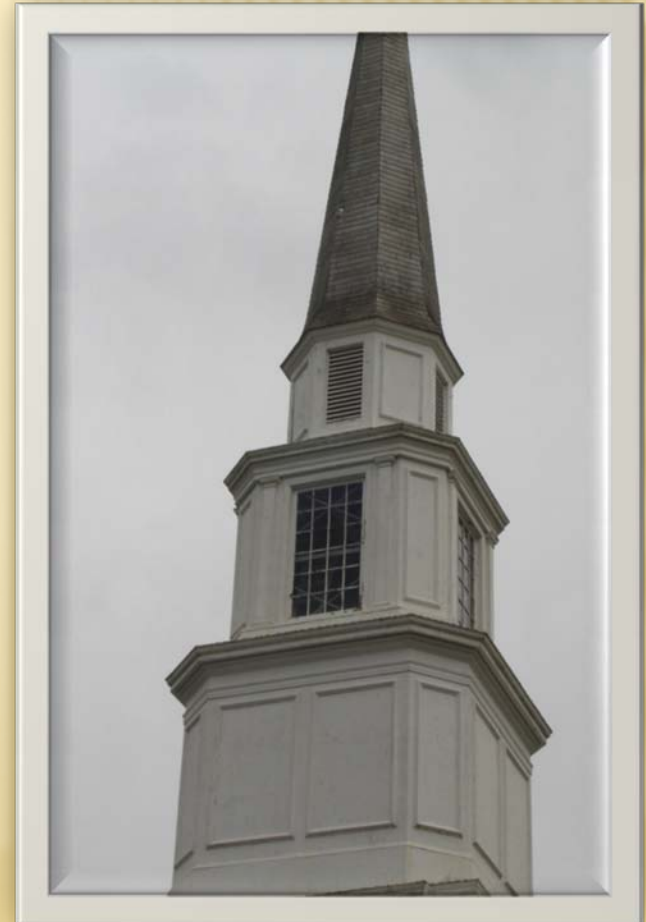
- Shingles loose and barely hanging on
- Window muttons missing and glazing compound gone – rot, water penetration
- Window and louver frames failed and rotting
- Rotted moldings, horizontal and vertical surfaces adjacent to previously failed flashing and remaining failed caulked joints all over the steeple
- Not financially feasible to remove old paint (Lead abatement & scaffolding involved) and prepare surface – much of the surface deteriorated and will not hold paint
- Entire steeple water tight integrity is compromised

- Replace the Steeple with a New Steeple

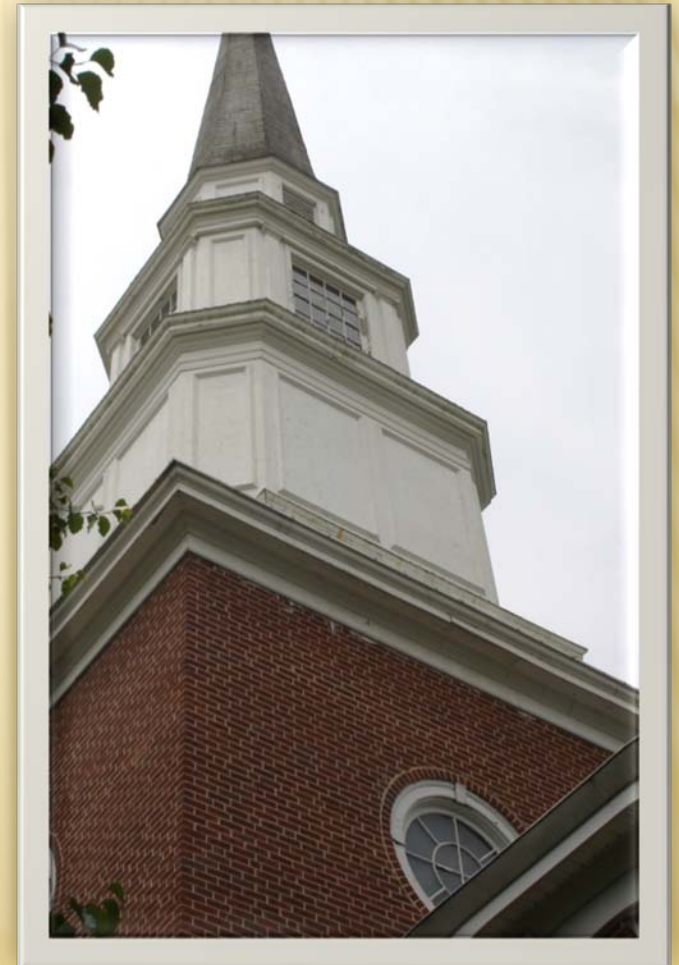
Current Steeple 62' tall
New Steeple 51' tall
Note: Duplication of current steeple over \$120,000

100% non-combustible fiberglass construction with structural steel frame to meet NC code

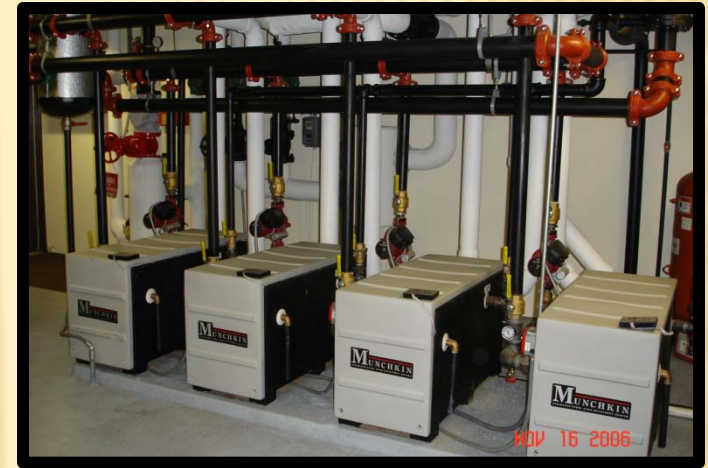
Multiple Boilers – 199,000 BTU each

- Replace the boiler and boiler room piping system with 96% efficient, stainless steel, cold start, load matching condensing boilers – 4 ea.
199,000 BTU
 - Utilize Vision 3 integrated boiler management system
 - Utilize Vision 2 integrated multi-temp, zone system
- Replace the heating piping in the original building
 - Replace/clean the heating element in each convector as necessary
- Install true secondary zone control for the offices, class rooms on 1st and 2nd floors and sanctuary
- Install separate heating and cooling system for the third floor class rooms

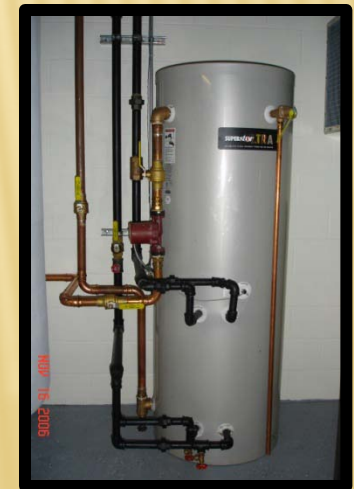
Typical Indirect Water Heater

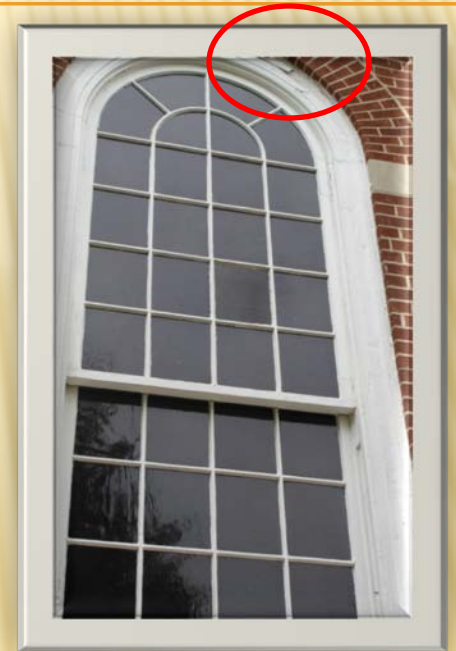
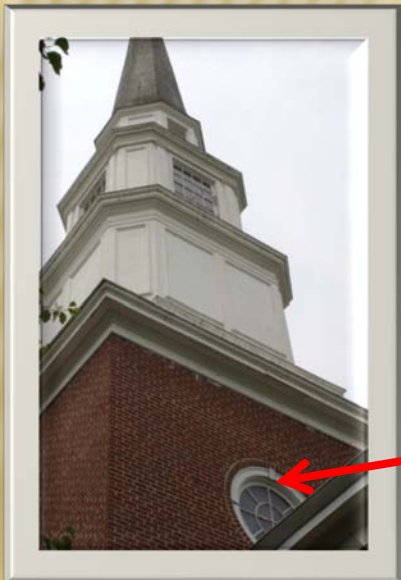
- Window frames and sash have deteriorated significantly requiring reglazing,
- Storm sash could be considered for comfort and energy efficiency

Moldings /muttons of the 'round' architectural window elements are, in many cases rotten and will have to be replaced – Cost is unknown

- Glazing and painting (incl. trim) \$5,000.00
 - **Note:** This is minimum requirement
- New PVC facings installed \$10,000.00
 - (Note: Custom profiles maintained)
- White aluminum storm Windows \$10,000.00
 - (Note: These are custom made)

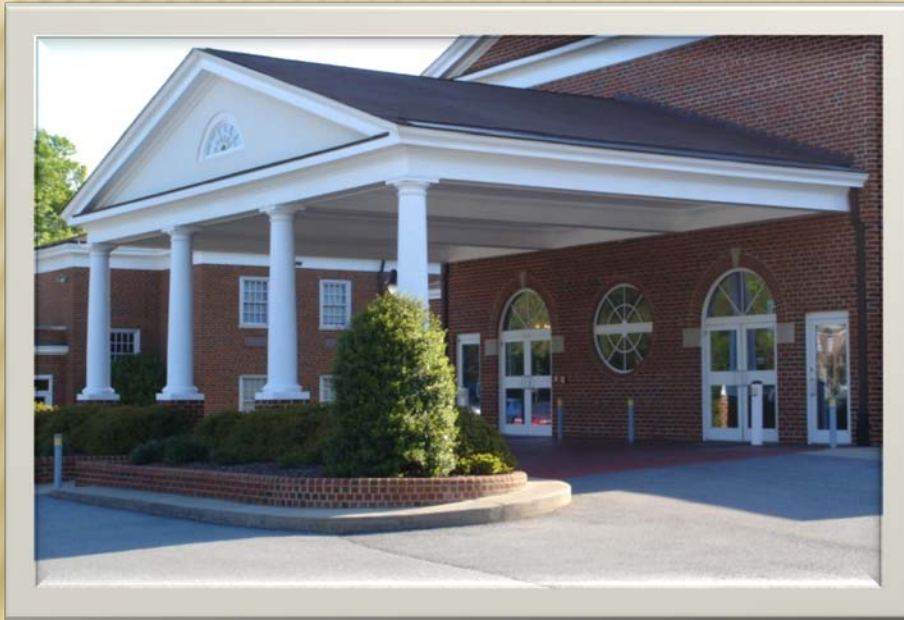
•Entry Portico

Architecturally similar to photo above

- Covering the entry doors leading to the renovated Entry Way and new Gathering Space.
- Weather protected entry for all persons entering our building
 - Especially helpful with funerals and weddings .
- All weather drive thru with slopped walkway providing easy and safe access for handicapped.
- Minimizes maintenance on the doors, etc.
